TECHNICAL BULLETIN

RELEASE DATE:	16 th October 2025
PRODUCT:	Sphere 270L Upright Refrigerator
APPROVED BY:	M. Vance
VERSION NUMBER:	1.0

AFFECTED MODEL: 700-22102 / 700-22104 SPHERE 270L Upright DC Compressor Refrigerator RH/LH W580xD630xH1523mm. UCF270R/L

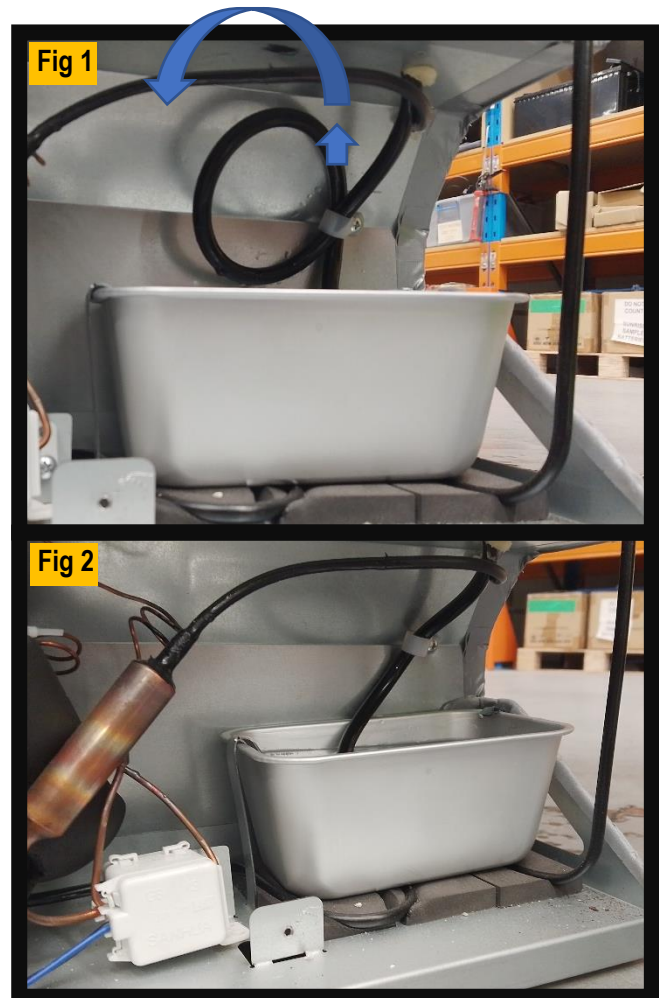
SYMPTOM: Excess condensation build up inside refrigerator / or not draining

CAUSE: Current routing of drain tube from factory

Shown in Figure 1 is the factory routing of the drain hose.

If the hose is in this configuration from factory, it may need to be re-routed to avoid water overflowing inside the fridge.

ACTION: Re-route drain tube

The re-route is to remove the loop from the drain hose route by simply pulling the hose up and out of the 'P' clamp holding the hose to the fridge body and to then ensure the hose sits inside the steel tray

Figure 2 shows the corrected route of the drain hose.
